526 B Street, Davis | [www.dsis.djusd.net](http://www.dsis.djusd.net)

# FACILITY CONDITION ASSESSMENT DAVIS SCHOOL FOR INDEPENDENT STUDY / DISTRICT OFFICE

Davis Joint Unified School District  
Facilities Master Plan

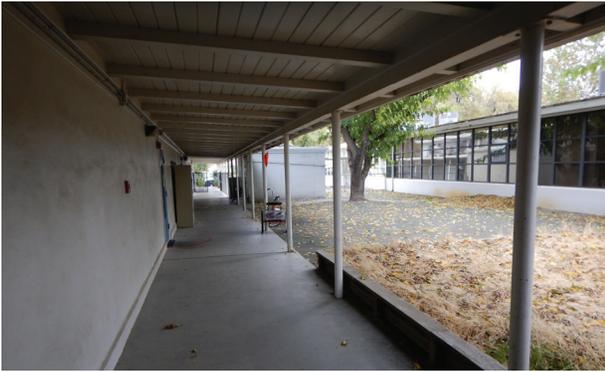
- Covered walkway structures are in fair condition, some rusting and minor patching needed.

Covered Walkway

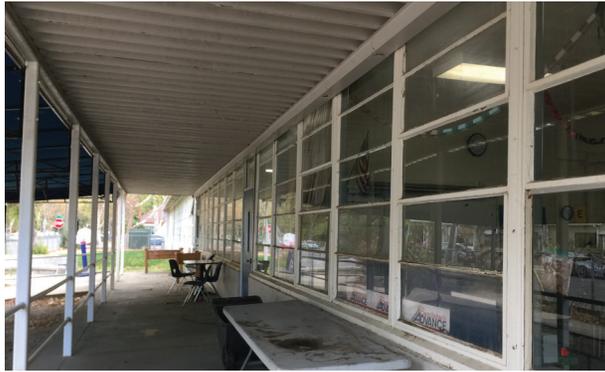
- In general, in fair condition throughout campus.
- Buildings will benefit from insulated double pane windows, they are single pane.

Windows

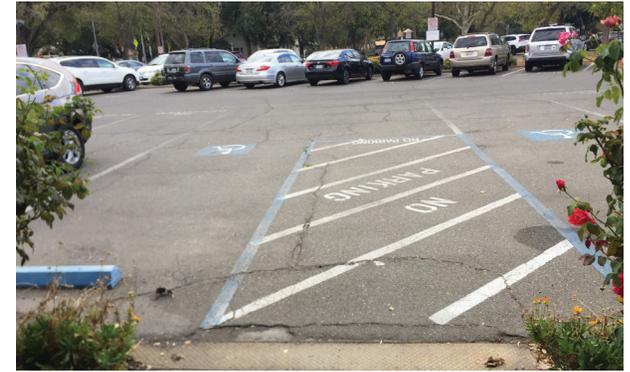
- The parking lot area that is shared with the District's office is not enough to accommodate current staff.
- Parking on street is used to mitigate problem, no drop off area available.
- There is no clear indication to the public which is the school's parking area for visitors or accessible stalls.

Parking

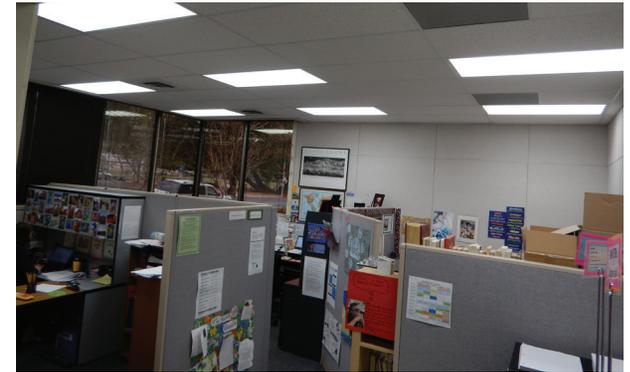
- In general, in poor condition throughout campus.
- Lack of privacy needed on some areas in the administration area.

Administration Office

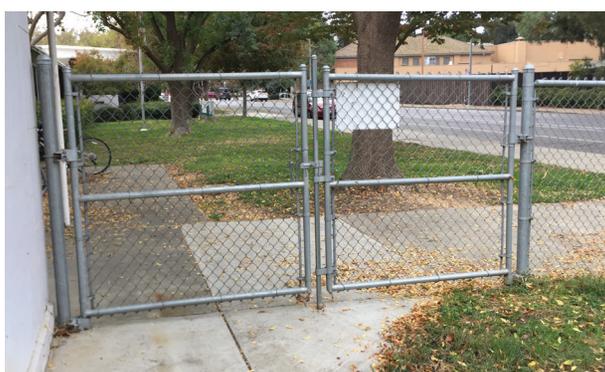
- The two gates on entry point from C street need to be upgraded for accessibility.

Fencing / Gates

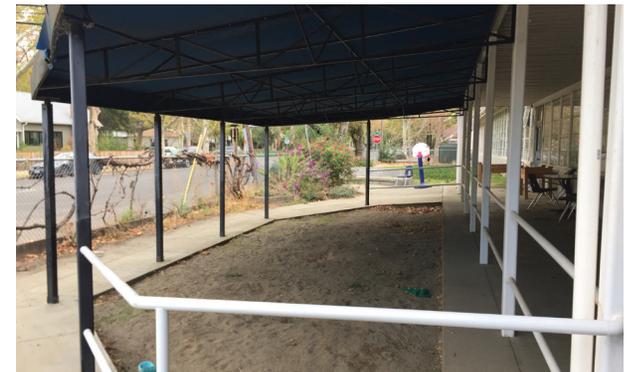
- In general, in good condition throughout campus, normal wear and tear.

Shade Structure

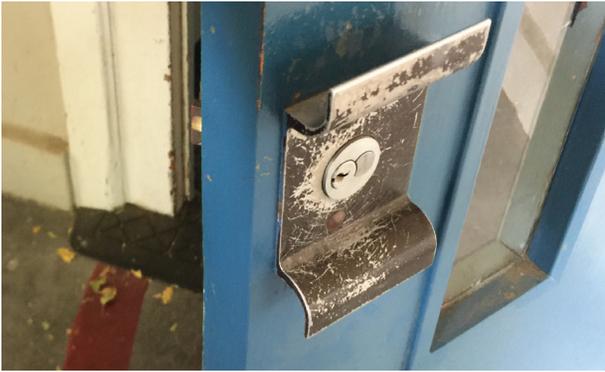
- Locks in general need to be replaced with accessible hardware.
- Classroom locks to be verified for compliance with classroom security locks by DSA.

Exterior Door Hardware

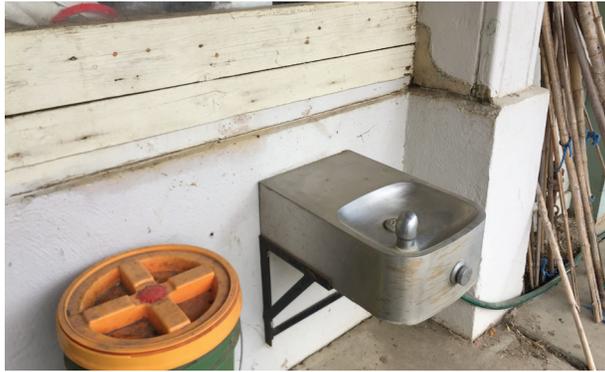
- Existing drinking fountain outside room 1 needs to be replaced with a hi-low accessible unit.

Water Fountain

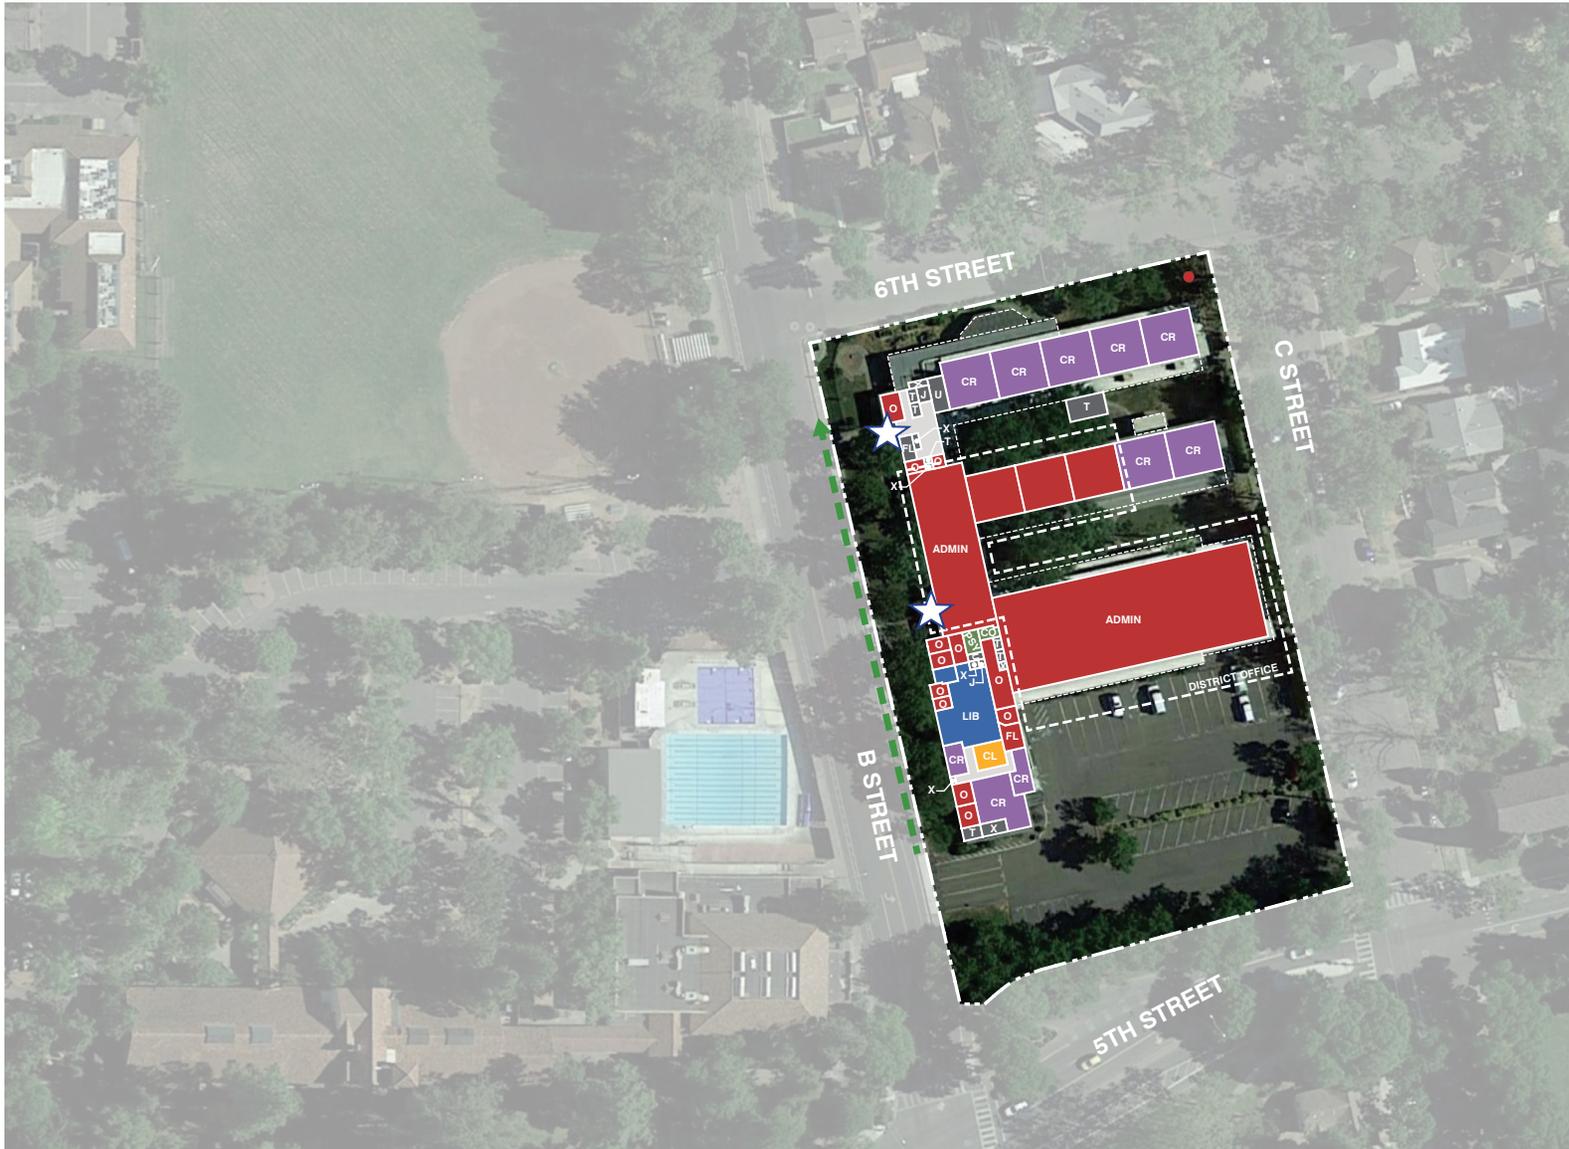
- Classrooms, CR**  
PK - Preschool, KG - Kindergarten  
TK - Transitional Kindergarten, CDC - Child Daycare, SDC - Special Day Class
- Electives / Labs**  
SCI - Science, CL - Computer Lab
- Student Services**  
CO - Counseling, RSP - Resource Specialist Program, SP - Speech, PSY - Psychology
- Shared Spaces**  
LIB - Library, MPR - Multi-Purpose Room
- Admin / Faculty**  
FW - Faculty Work, FL - Faculty Lounge, O - Office, CF - Conference Room
- Support Spaces**  
X - Storage, T - Toilets, U - Utility, J - Janitor, K - Kitchen
- Portable Classrooms
- Main Entry
- Drop-Off
- Electrical Transformer
